PAGAN newsletter 1982

The Earthquake of July 8, 1975 in Pagan

Repairs Activities 1975-1982

Presentation of a monument:
THE KUBYAUK-GYI TEMPLE
no. 1323/647
in Myinkaba village

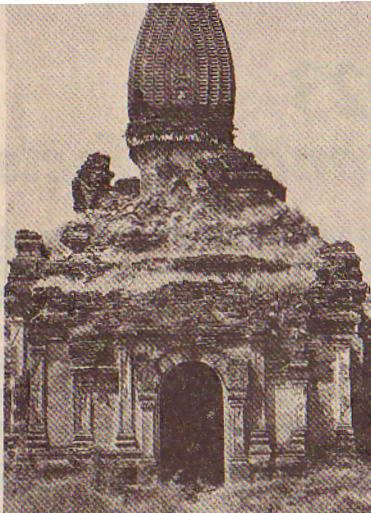
Temple no. 1852 damaged by the 1975 earthquake
Collapse of the vaults on first storey.

Structural damage. Structural damage to the upper parts was usually due to an outward movement of the top of the walls and desolidarization of the structure under seismic waves, leading to cracking or opening of vaults and arches, as well as cracks along the lines of least resistance in the walls. In the worst cases vaults and terraces collapsed.

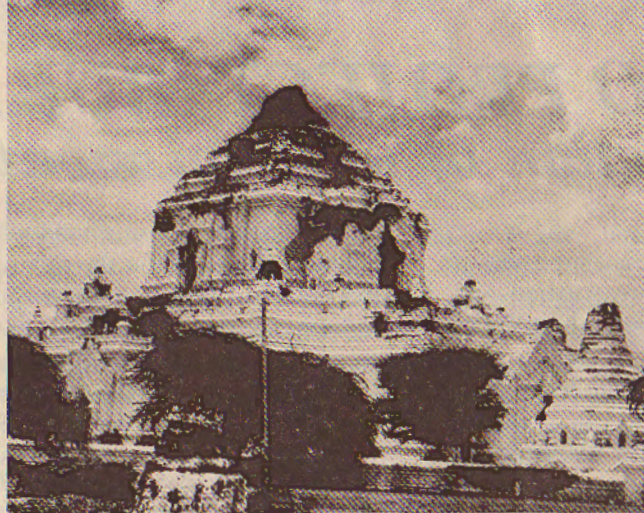
Gawdawpalin temple (no. 1622), 1975.
Condition after the earthquake.

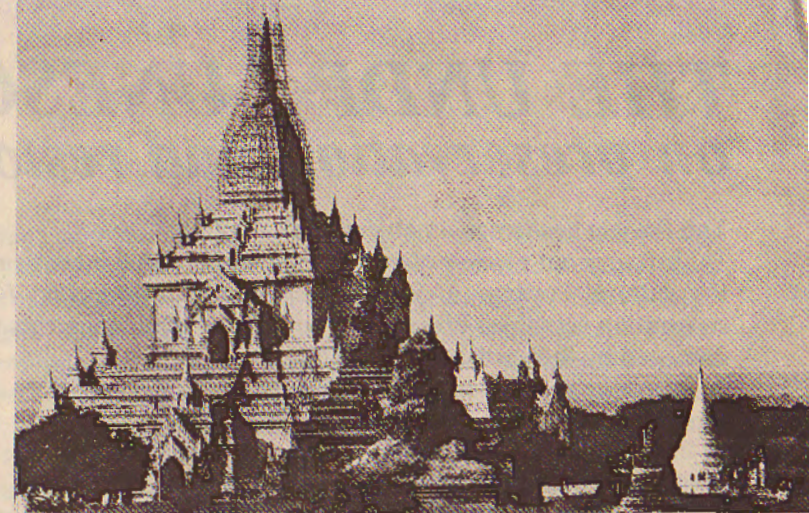
Gawdawpalin temple, March 1982.
Repairs work under completion.
This marks the end of repairs for the 44 monuments on the priority list.

Progress of work. The 44 monuments selected by the Advisory Board are now effectively repaired: Gawdawpalin temple, the last one, is being completed in April 1982. The Special Works Unit of Construction Corporation has been commissioned by the Director of the Department of Archaeology to implement the work on these priority monuments. In addition, the Pagan Branch of the Department of Archaeology completed repairs on 71 other monuments, generally on modest size but of great archaeological and artistic interest, and 24 other monuments have been repaired by their respective Trustees, bringing the total to 139.

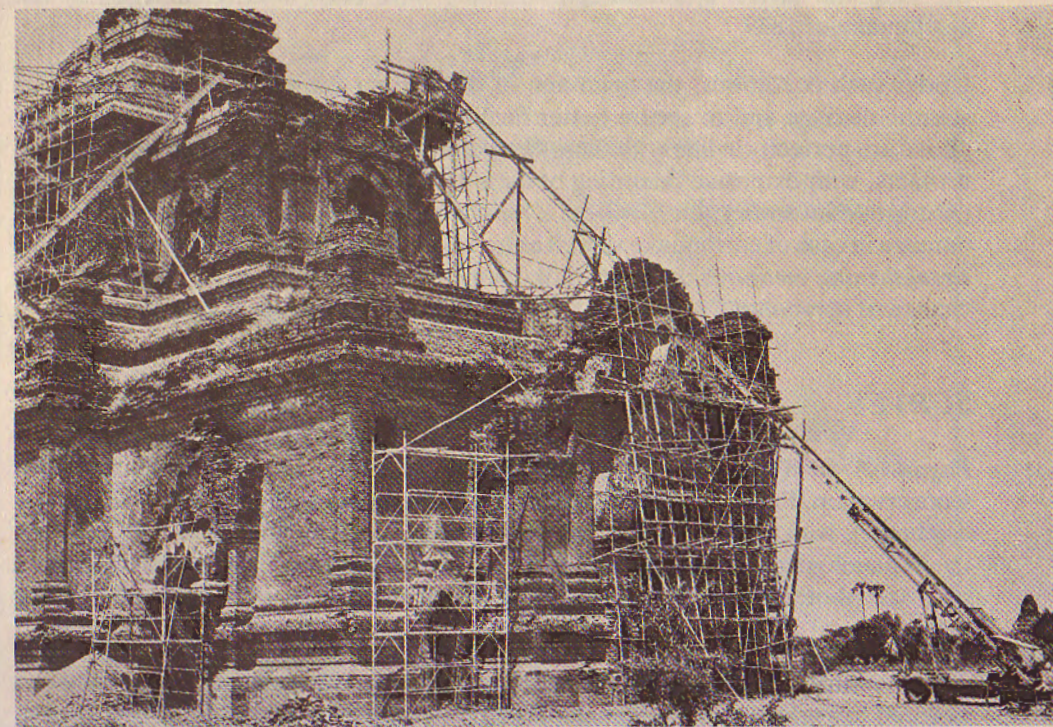
Ywa-Haung-gyi temple (no. 1791), March 1982.
Under restoration with financial assistance from Federal Republic of Germany.

Lastly, the Government of Federal Republic of Germany has given financial support for the restoration of one monument, the temple N° 1791 – Ywa-Haung-gyi, presently under way.
